Hammering Wear Impact Fatigue Hypothesis WEC/irWEA failure mode on roller bearings

Presented by Johan Luyckx
Manager Product Integrity Management
Hansen Transmissions International nv
Kontich Belgium

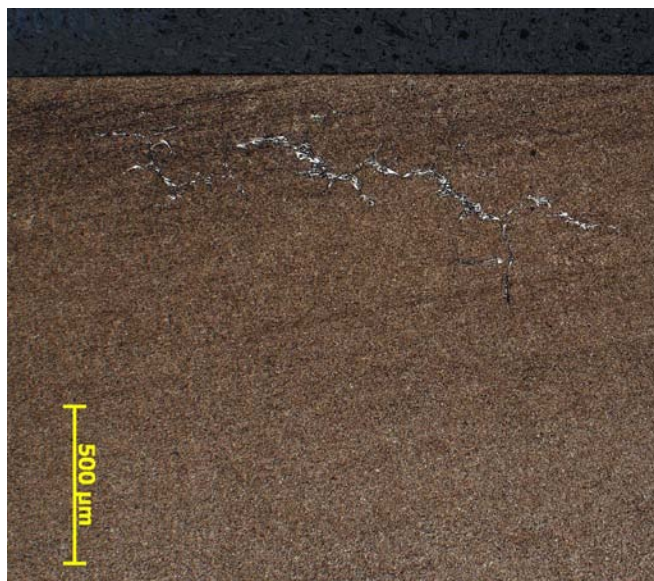
Small network

Case carburised bearing steel : WEC/irWEA failed bearings

Subsurface networks with cracks and white etching area's

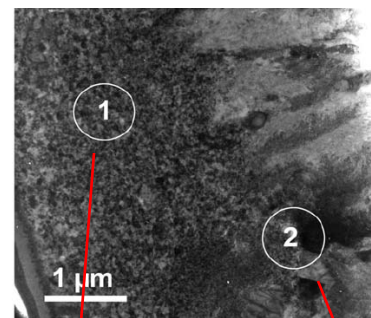
Electron
microscopy

Nanograins in white
etching material area's

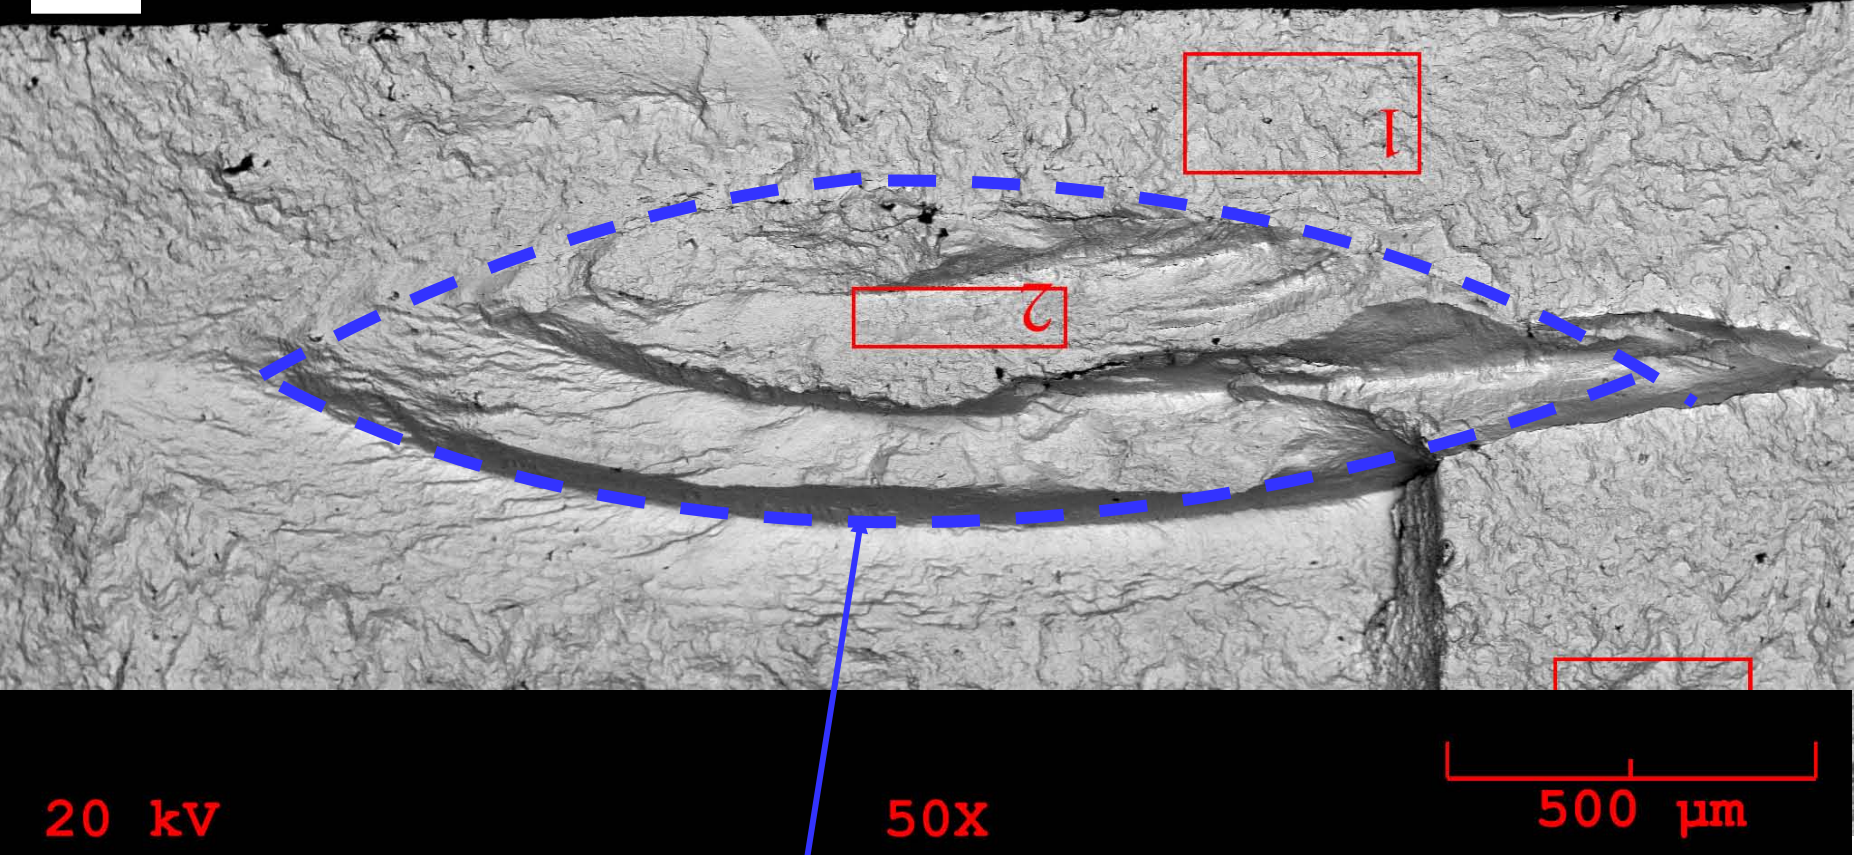
V-segment with white etching material
area's in parallel part of the crack

V-segment and

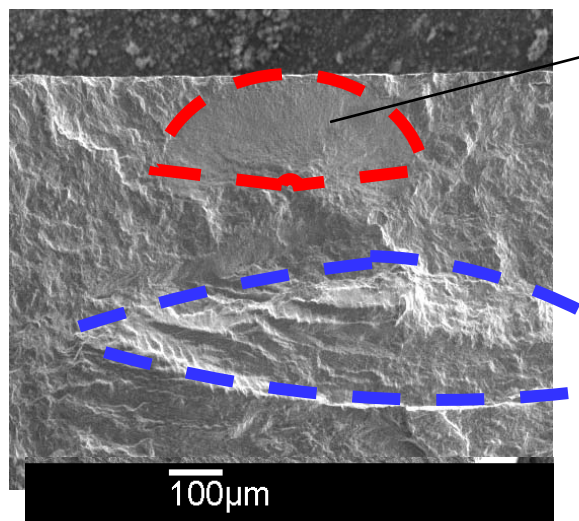
SEM
x 40

Flat crack surface with **voids**
surrounded by elevated borders

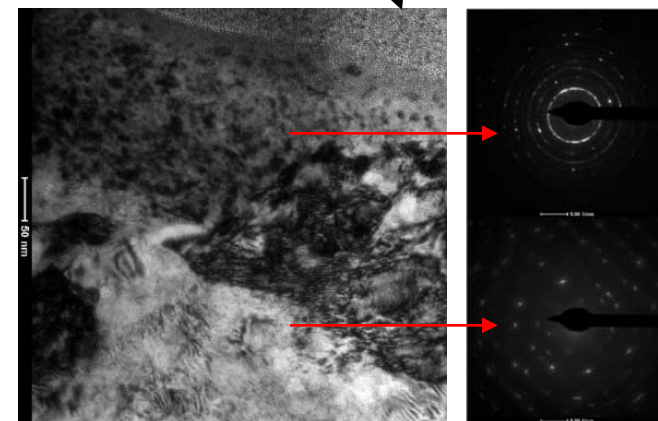
Electron
diffraction

V-segment and semi
circular crack

Nanograins at crack surface

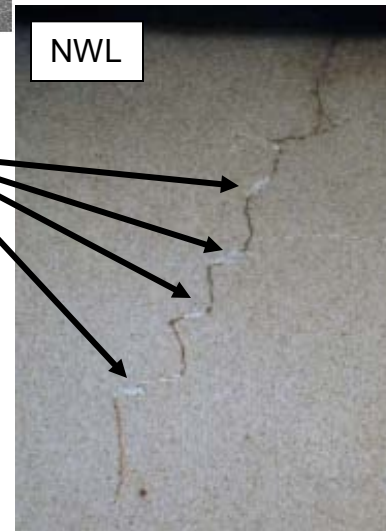
Perpendicular
cutting (before
crack opening)
and later
microstructure
etching

Semi circular crack and large
V-segment with **white etching**
material area's in parallel parts
of the crack

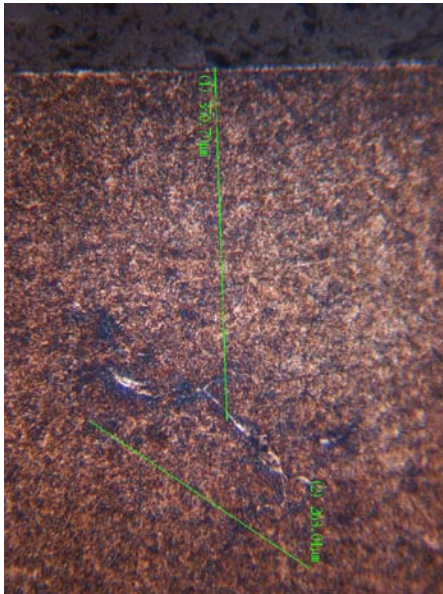
Bainite

Small subsurface damage = local subsurface damage initiation

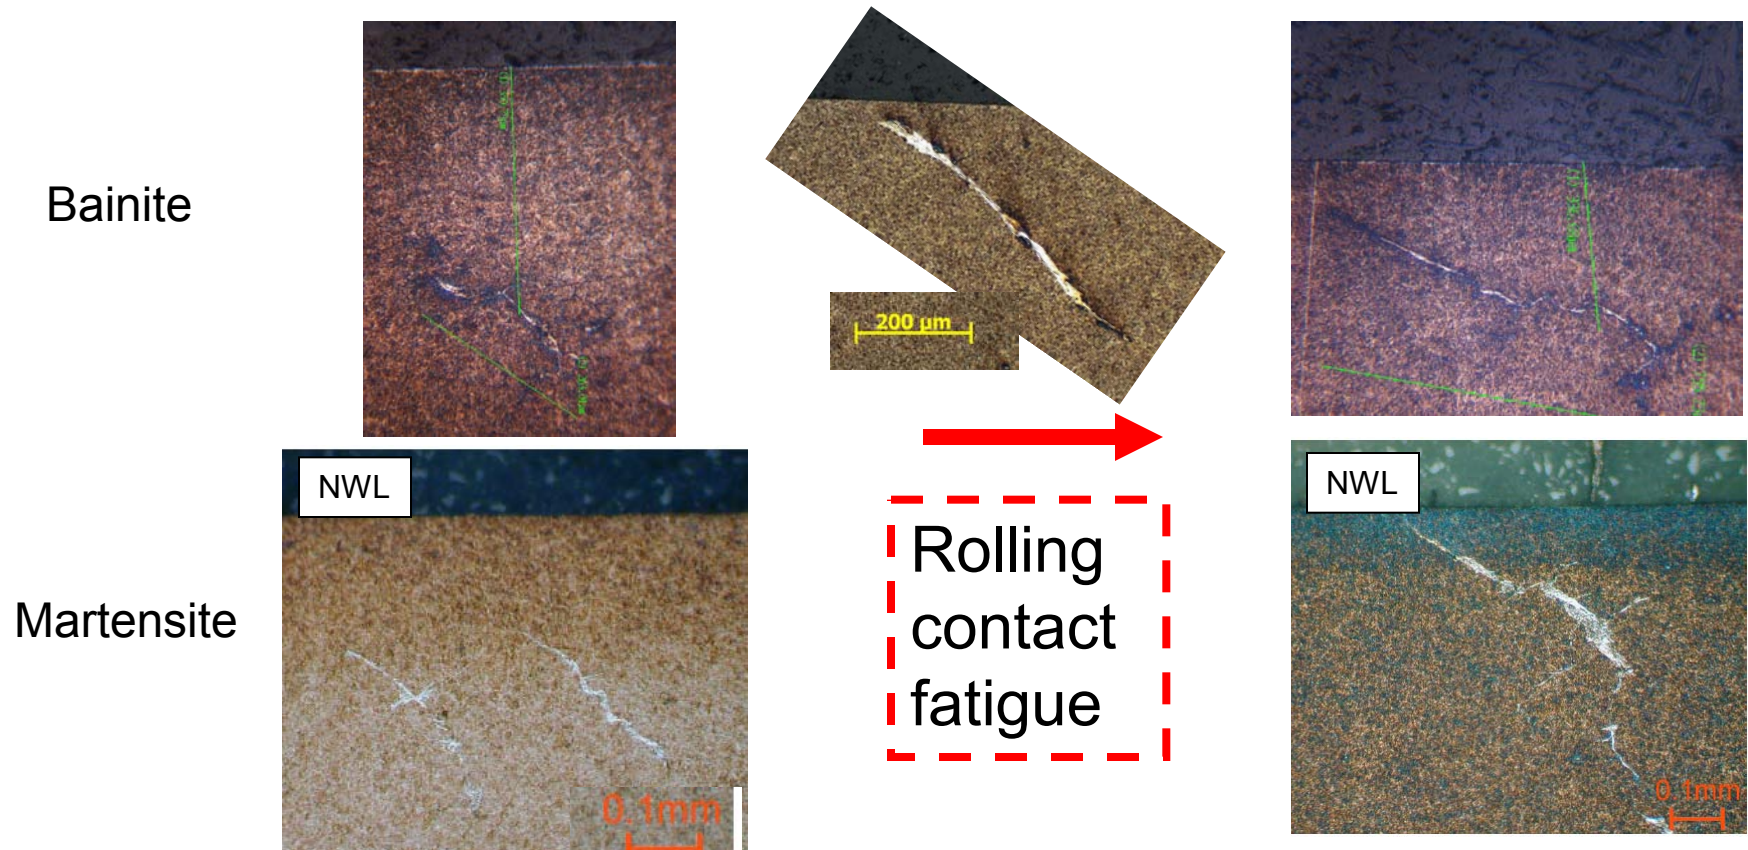
- Local subsurface damage initiation = big inclusion. Crack development via classical rolling contact fatigue towards the surface.

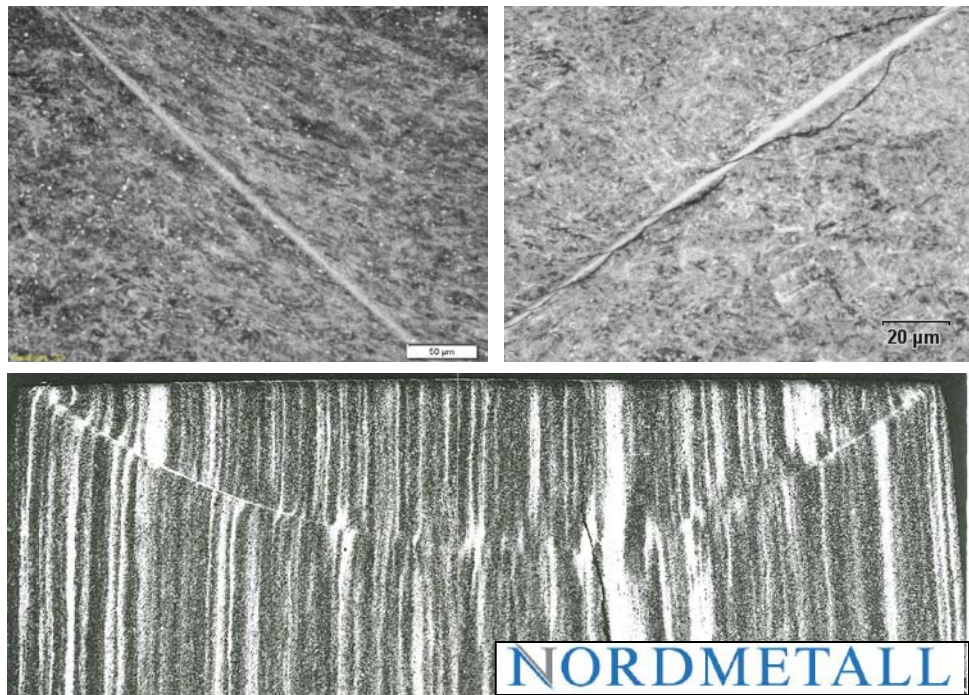
- adiabatic shear band (ASB) = straight or curved thin band
- nano grain sized microstructure, thus white etching
- generated by an impact load

ASB in bearing steel (upper left and right) and 57HRC steel (lower) generated by an impact test

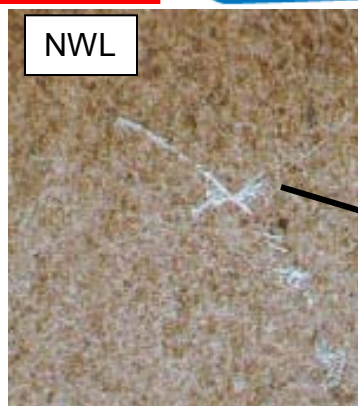
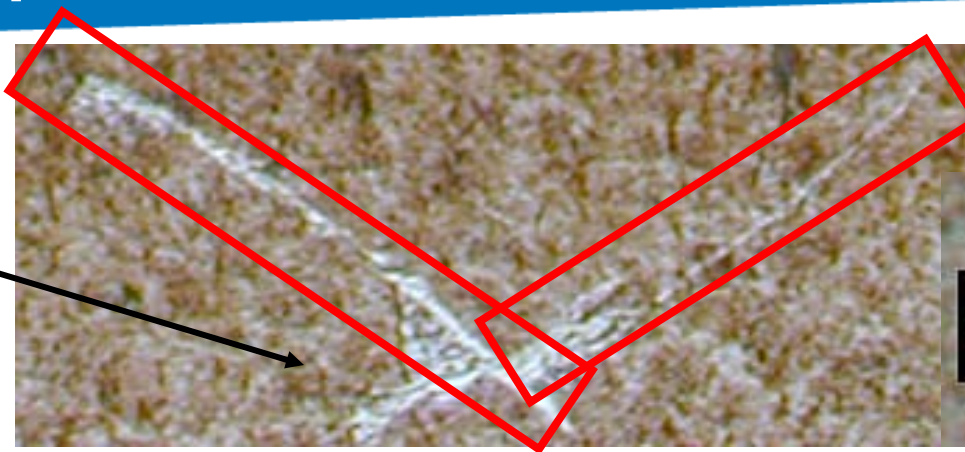
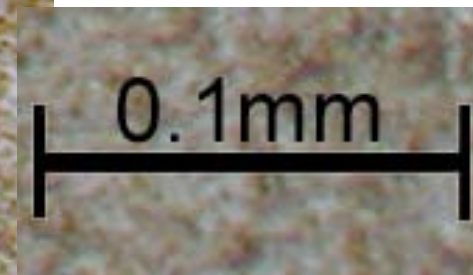
White bands are interpreted as adiabatic shear bands

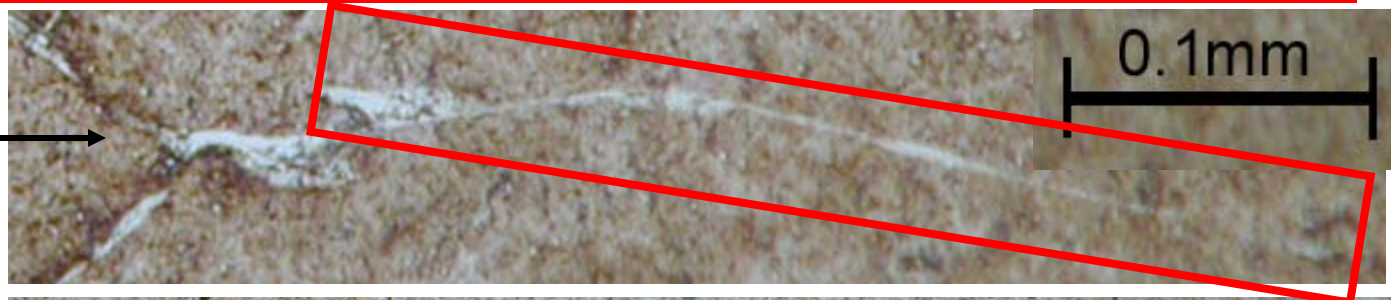
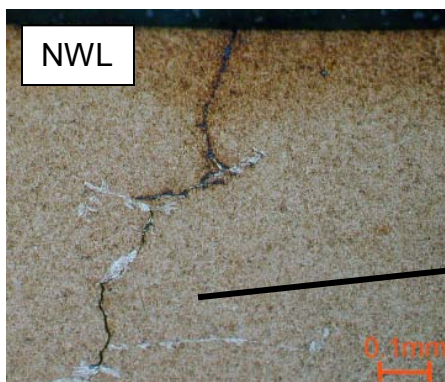
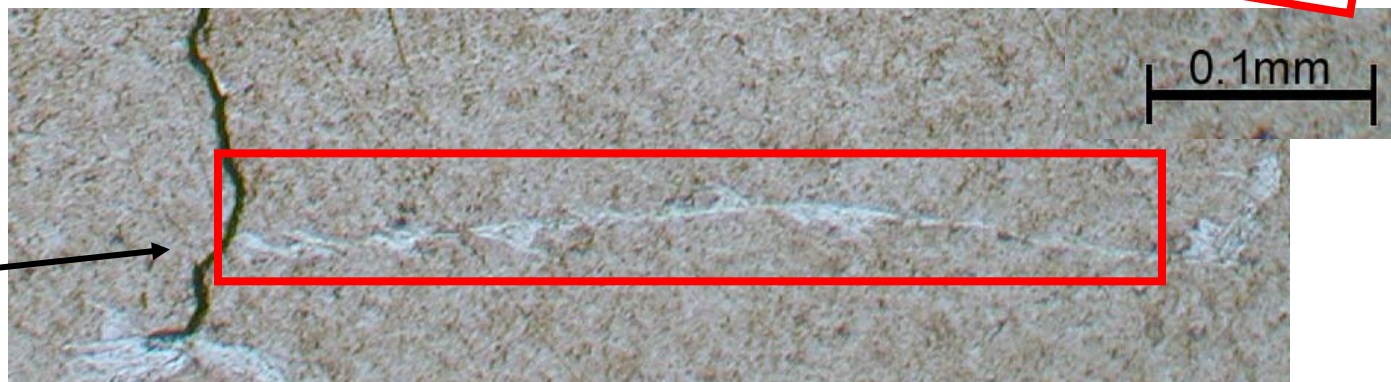
Adiabatic shear band and crack

Crack propagation

- + Development of white etching area's at the crack and ASB borders

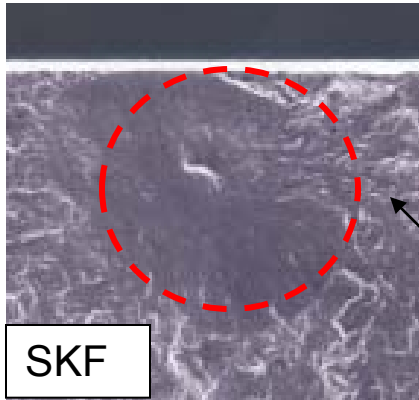
▮ (Semi) circular crack surface is interpreted as **spallation crack** from an impact load based on :

- circular shape with central origin
- surface morphology : flat and voids
- interaction with inclusions
- presence of nanograins on crack surface

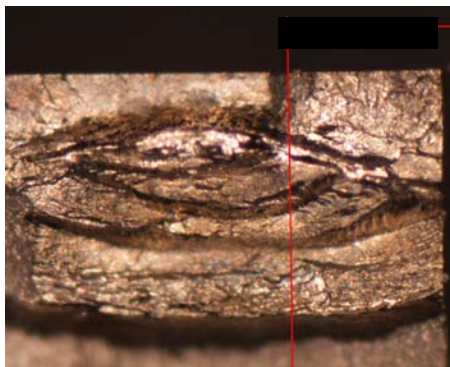
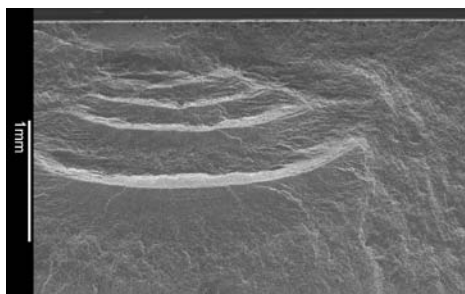
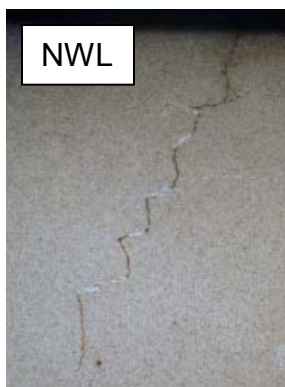
▮ V-segment is interpreted as crack surface from a wave load based on :

- V-spreading and stop with depth is propagation of a body wave
- stepped crack pattern : 2 wave systems generate cracks in 2 directions

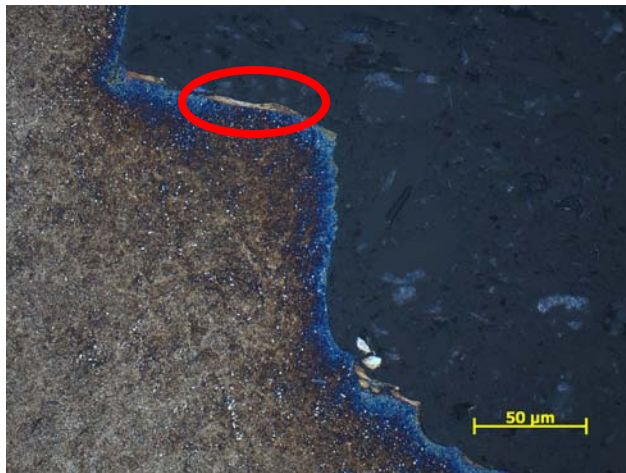
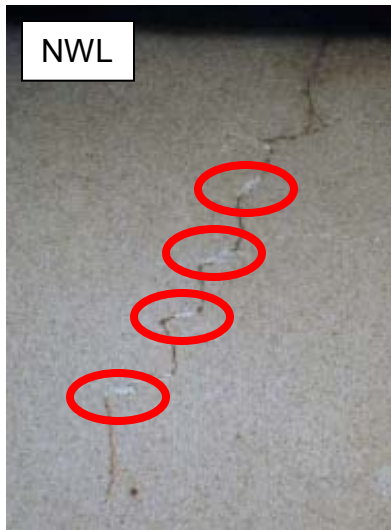
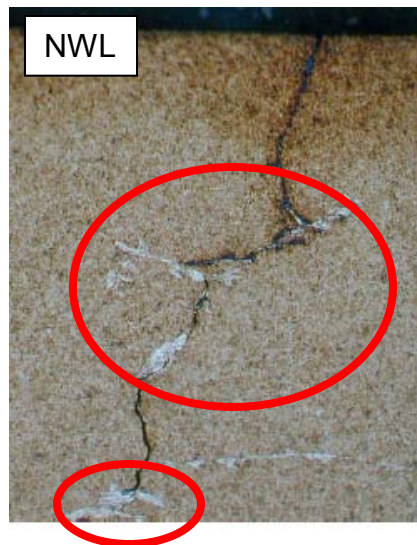
White etching at parallel part of the crack

- White etching area's at parallel part of crack in V-segment :
 - identical generation mechanism as in rolling contact fatigue with crack development
 - and thus consequential damage

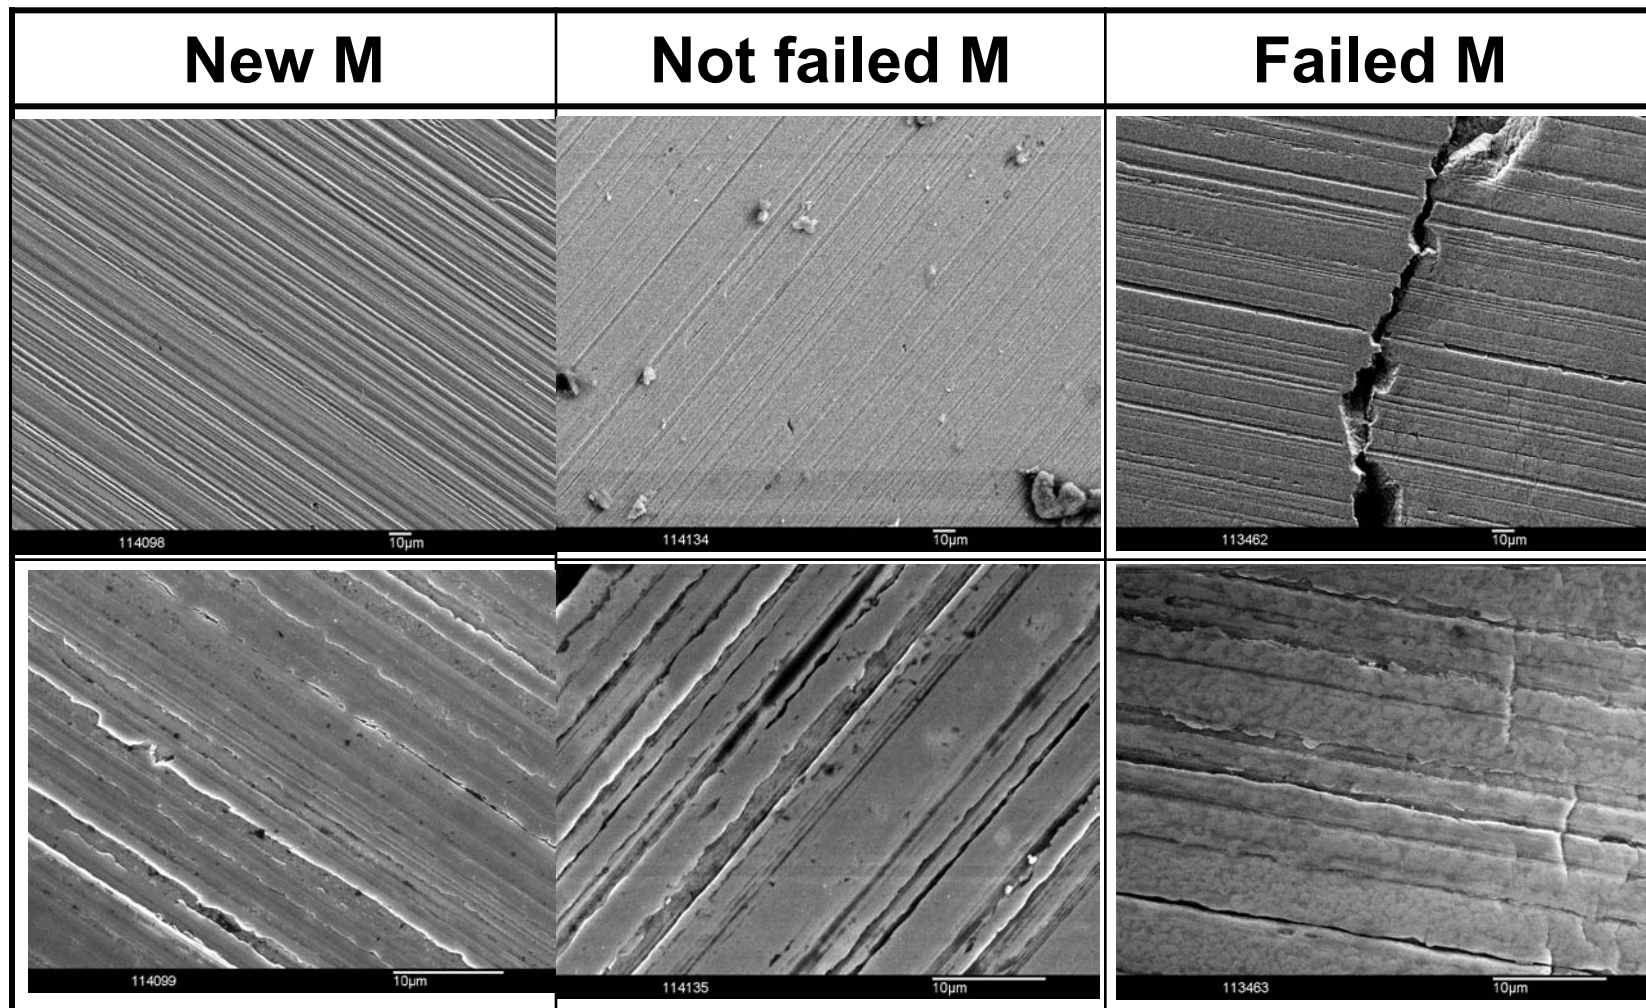
Comparison of raceway surface : **martensitic** = M

Hammered appearance of raceway surface in a WEC/irWEA critical application.

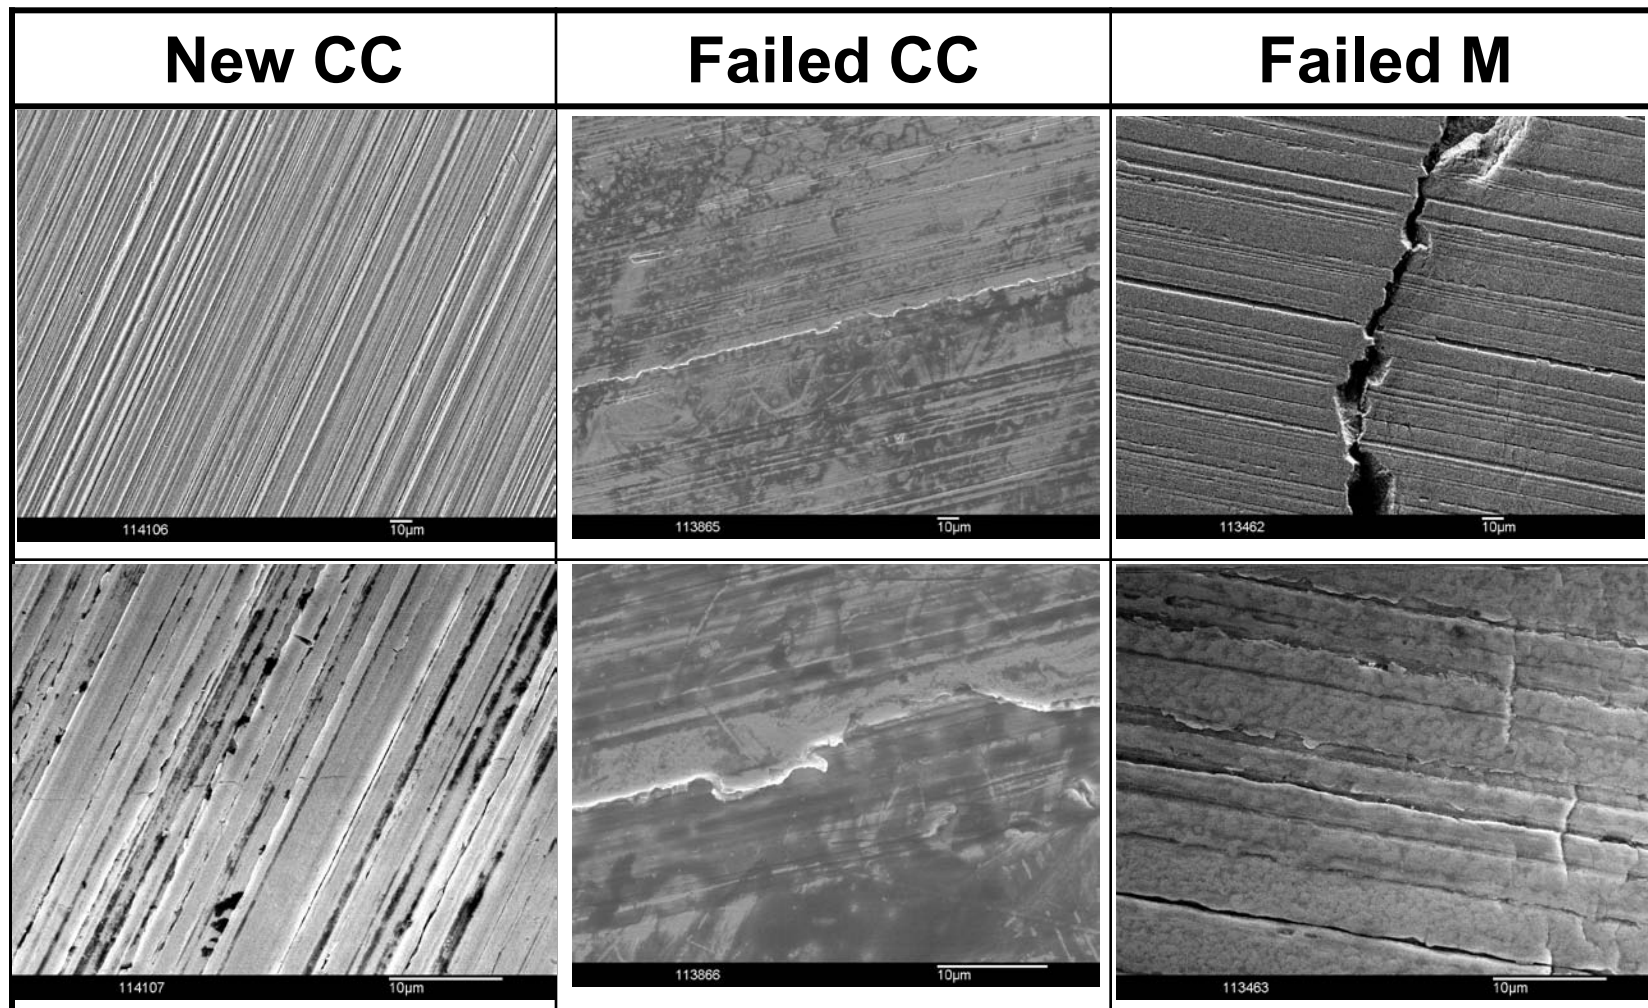
Comparison of raceway surface : case carburised = CC

Hammering appearance on raceway surface is **smaller** in comparison with martensite. Some case carburised asperities tops have minor flattening.

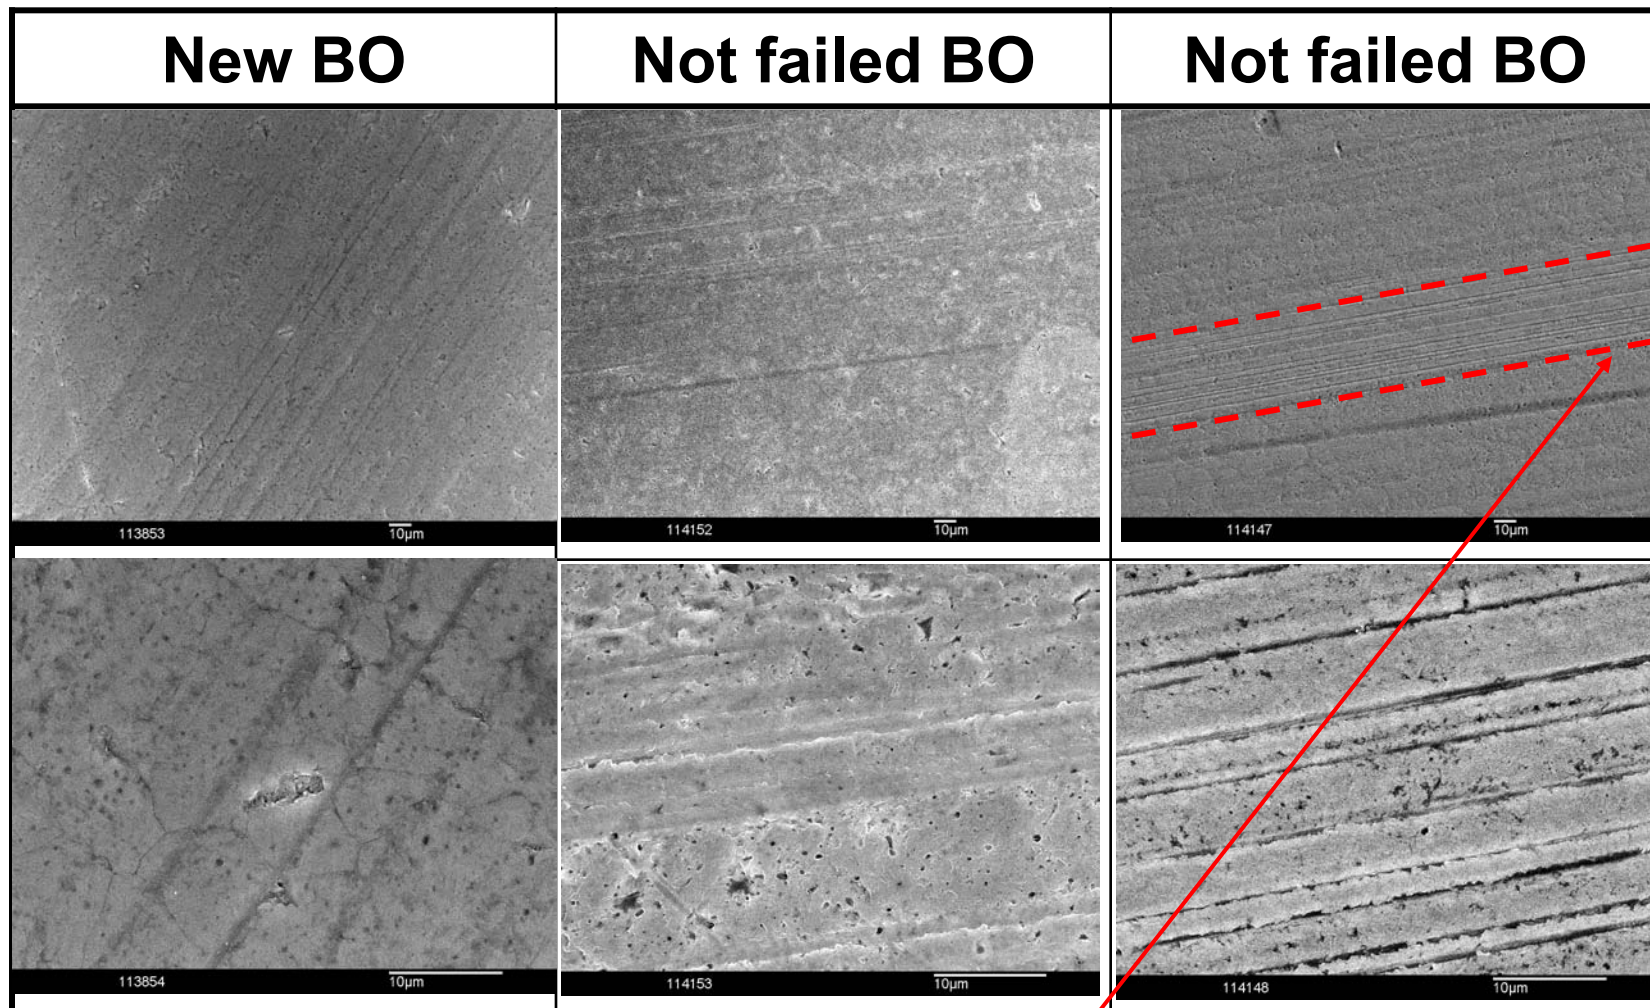
Comparison of raceway surface : black oxidised = BO

Black oxidised coating limits the development of hammered appearance to isolated lines or small bands

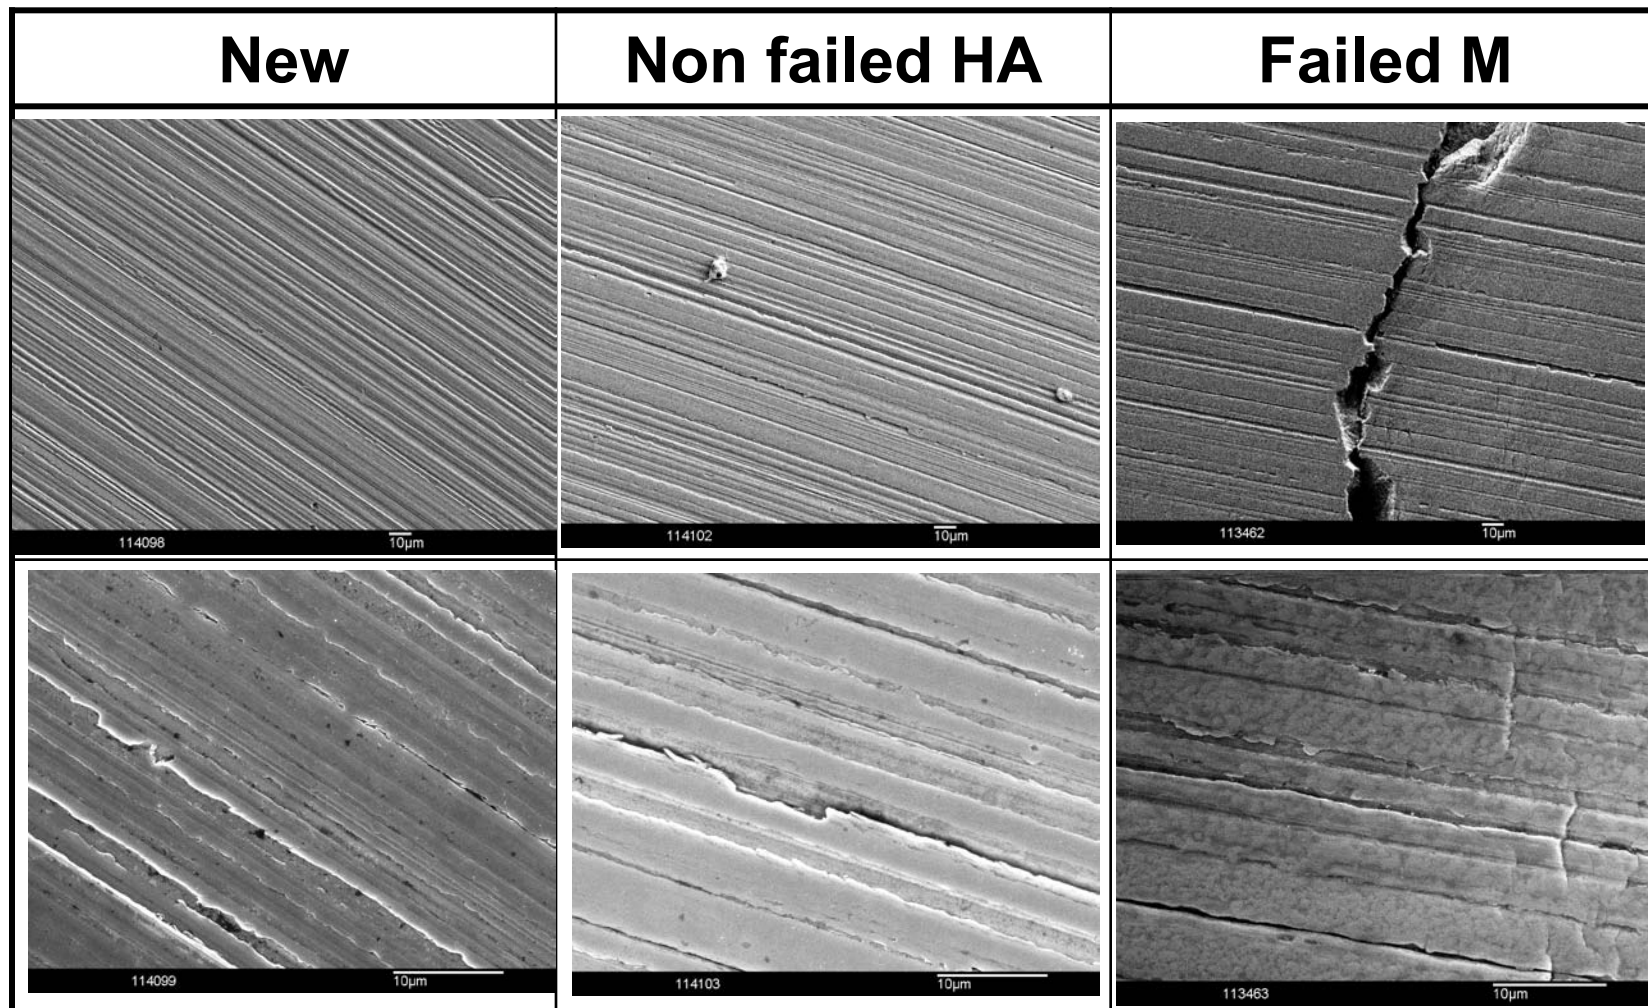
Comparison of raceway surface : assembly at 130 C = HA

Visual appearance is less hammering for HA compared to M.

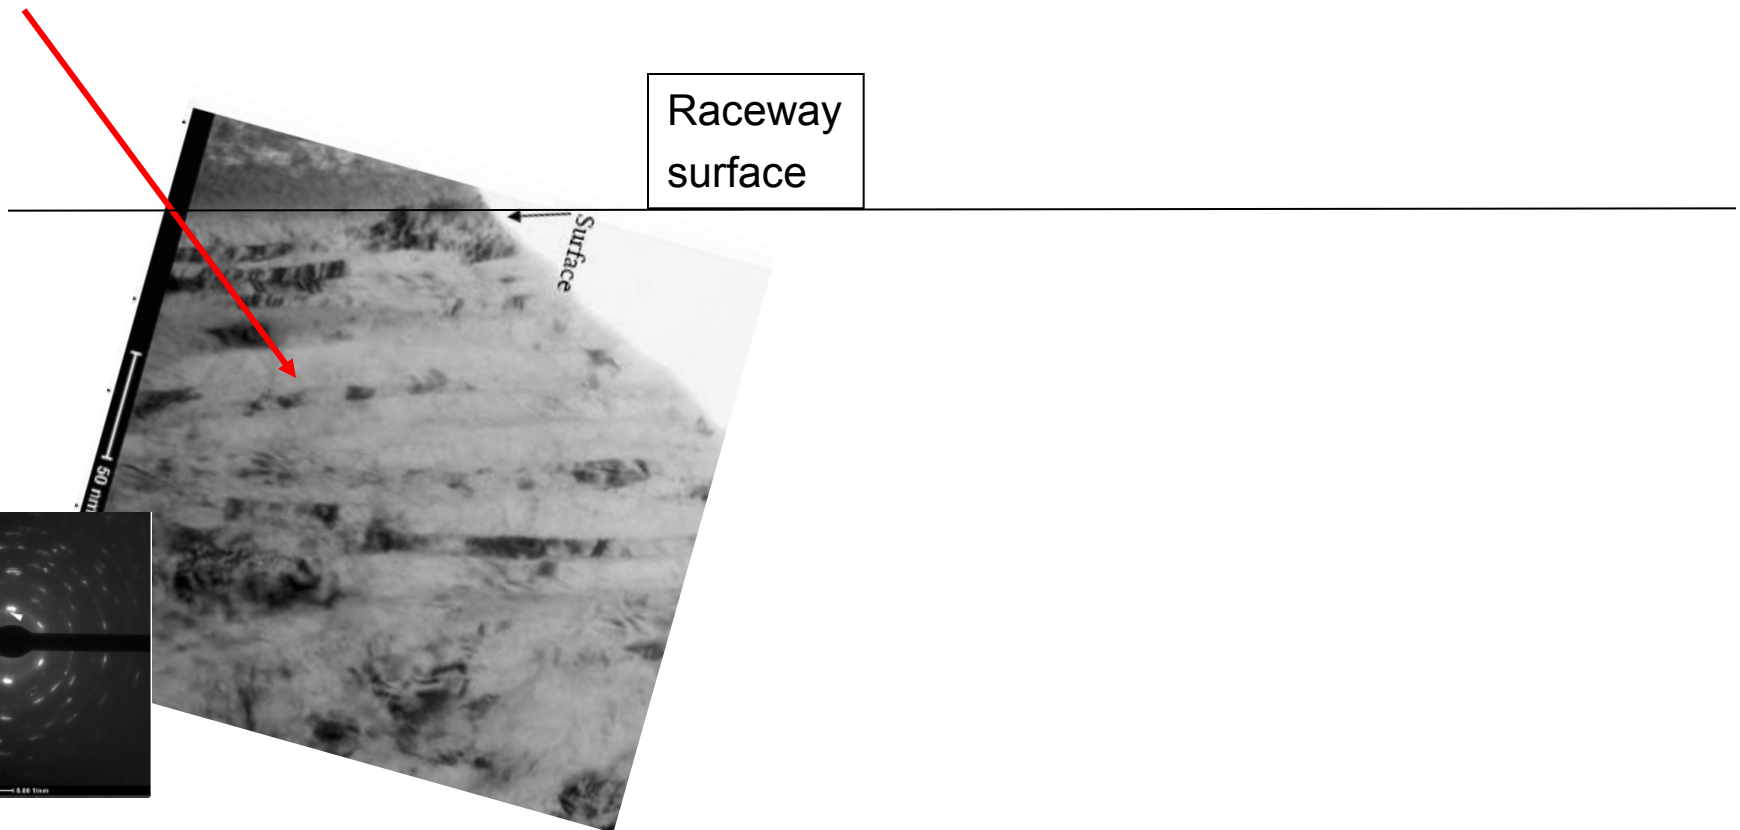
New bearing raceway surface \Rightarrow
100/200 nm layer of small lamellar
grains about 20/30 nm thick

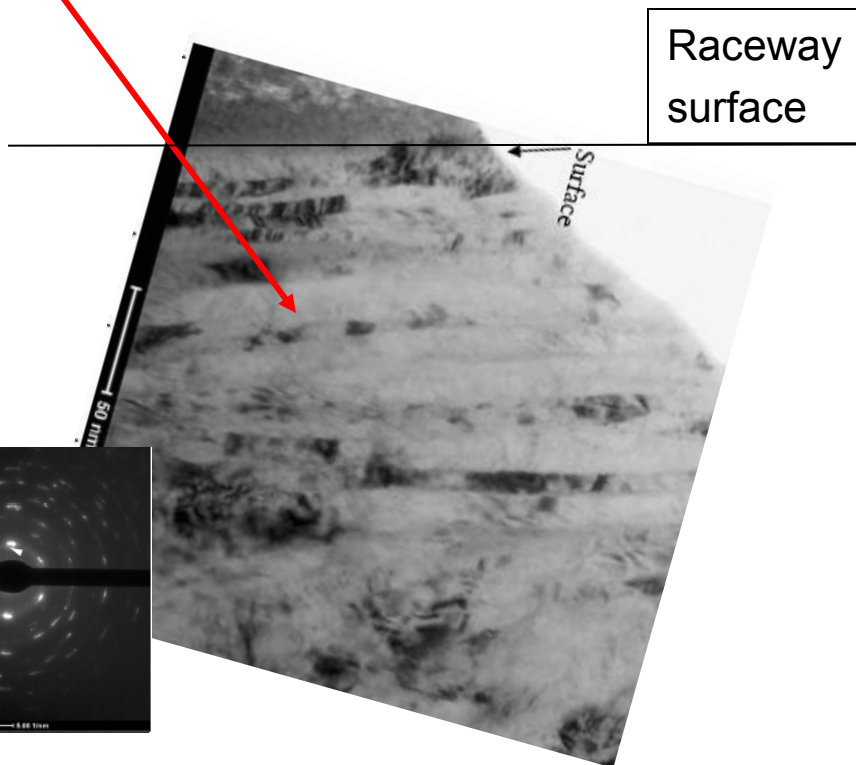
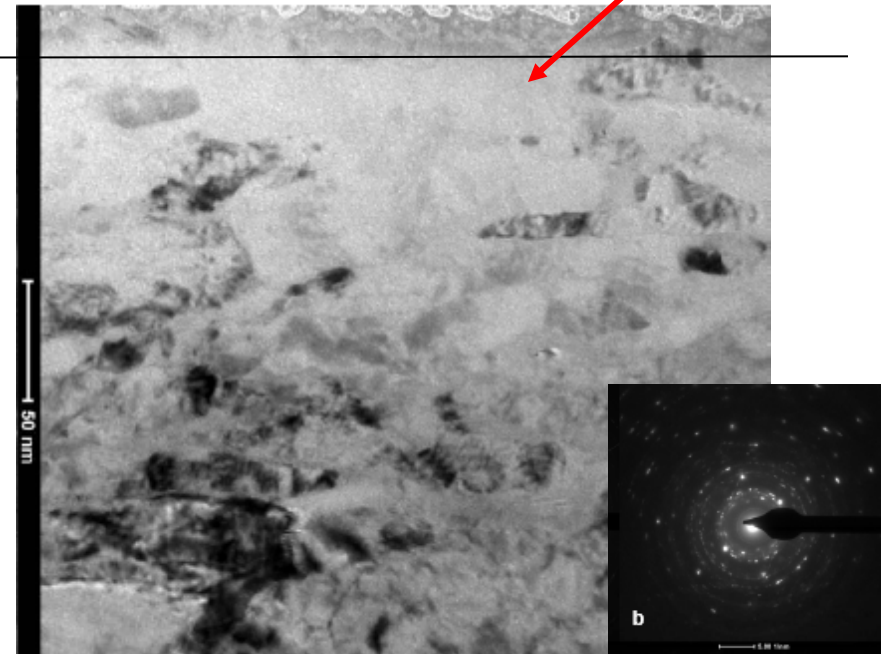
New bearing raceway surface \Rightarrow
100/200 nm layer of small lamellar
grains about 20/30 nm thick

After bearing assembly at 130 C
 \Rightarrow 100/150 nm **recrystallized layer**
at raceway surface with grains of
about 5/10 x 30/40 nm

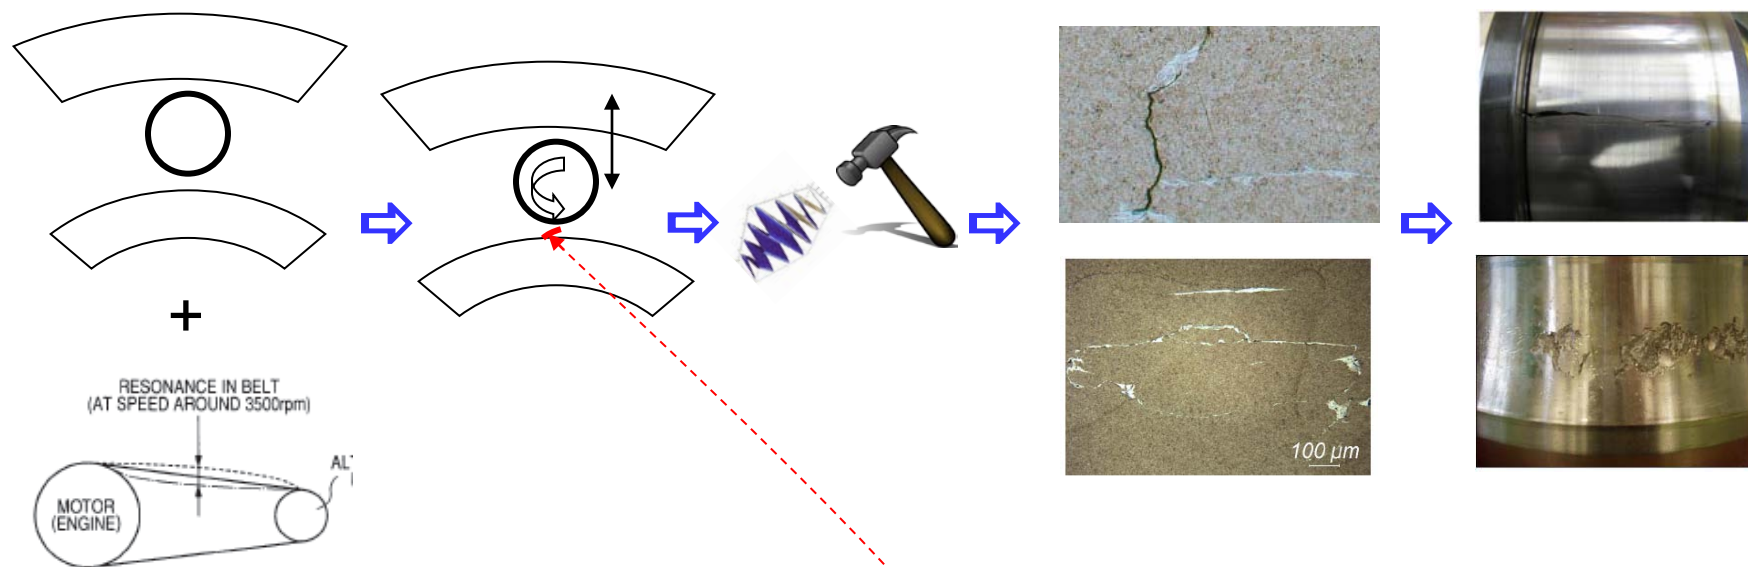
roller bearing
+
dynamic load
conditions
from application

⇒ raceway hammering
& shear stress

= **hammering
wear particle**

⇒ subsurface
impact
damage

⇒ WEC/irWEA
bearing
failure

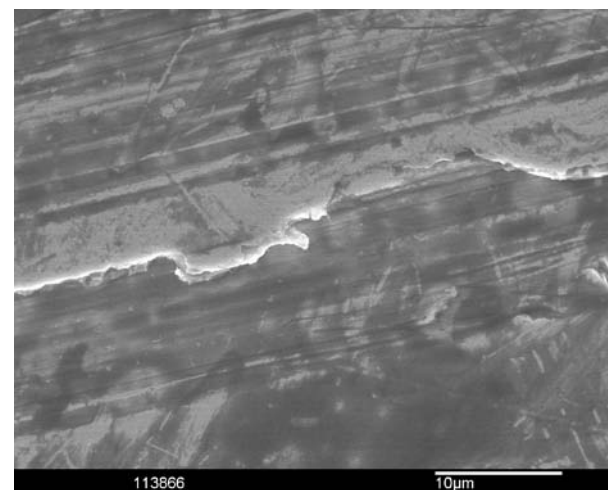
Raceway
case
carburised
bearing
supplier

Comparison between raceways. Lower picture is Hansen case carburised without hammering wear. No WEC/irWEA failures on Hansen case carburised raceways.
